Review and analysis of the explosion accident in Drevja, Norway: A consequence of fire in a mobile explosives manufacturing unit (MEMU) carrying precursors for the on-site production of bulk explosives.

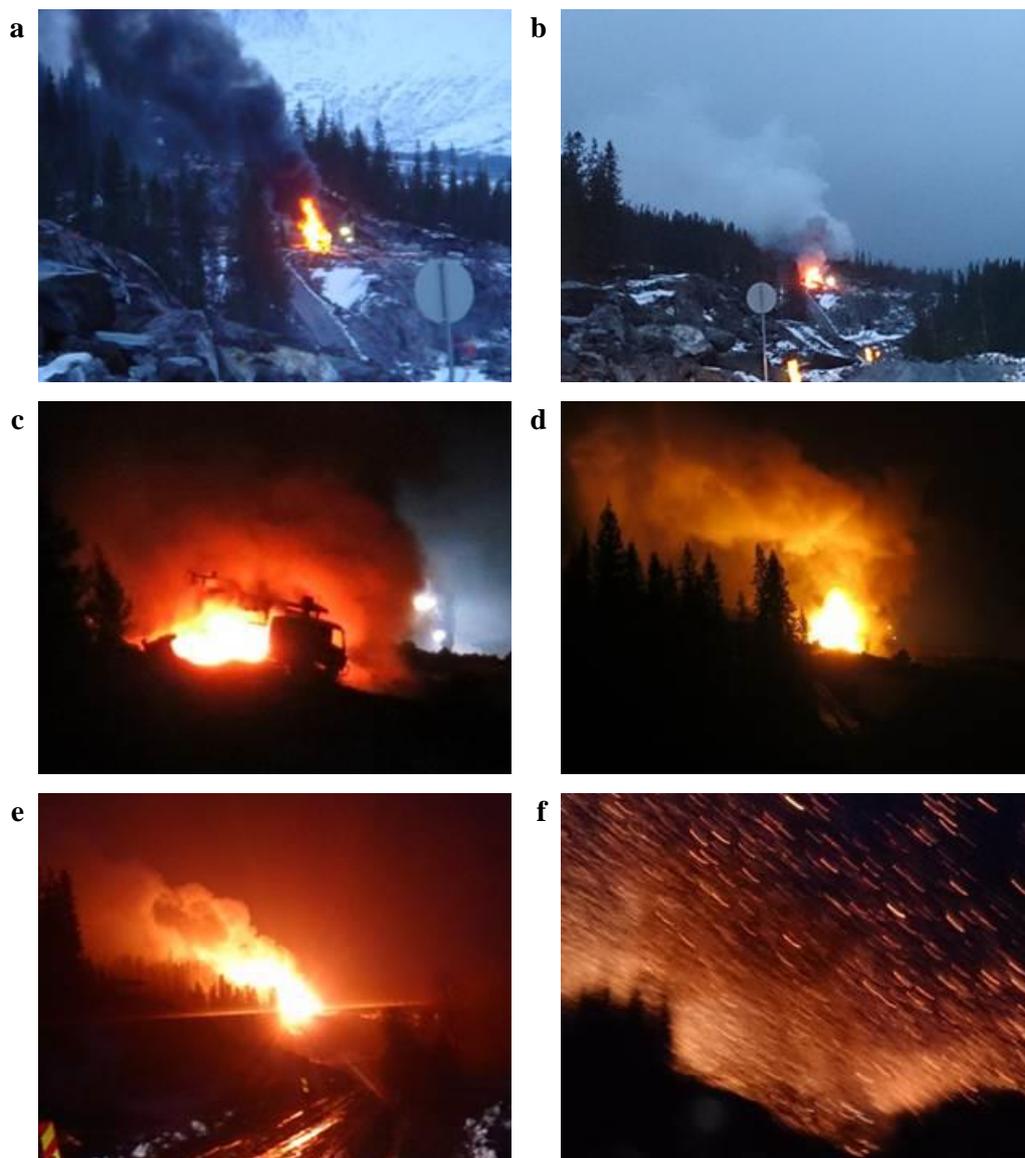
towards him from underneath the dashboard. First, the operator, aided by two constructors at the site, commenced fire-fighting measures. These were aimed at the fuse-box positioned on the right-hand side of the dashboard inside the cabin, as it was thought to be the origin of the fire. After several unsuccessful attempts, the fire-fighting was continued from the outside towards the engine compartment. Still, the fire could not be extinguished and evacuation was commenced at 1.07 p.m., followed by a manual activation of the automatic fire-fighting system in the engine compartment as a last attempt to quench the fire. However, this also failed. Shortly after the fire-department was informed at 1.11 p.m., all contractors and local residents in a range of 500 m were being evacuated. Both the color of the fumes and the intensity of the fire varied throughout the event (Fig. 1a-e).

Fig. 1: Pictures showing the course of the fire: a) 1:26 p.m.: Intense fire accompanied by black smoke. The cabin is completely engulfed by the flames. Flames can also be seen on the ground in front of the truck. b) 2:23 p.m.: The cabin is almost burned out and the fire has propagated backwards. The truck load is now immersed in flames. Large white and grey fumes are observed. c) 3:15 p.m.: the fire has been calm for over 30 minutes. The cabin is completely burned out while the remaining tanks are incandescent. d) 3:21 p.m.: The fire suddenly intensifies and immerses the truck. e) 3:26 p.m.: The fire intensifies towards the rear of the truck with high flames seconds before the explosion. f) 3:26 p.m.: Glowing droplets filling the sky few seconds after the explosive event.

The fire seemed to calm down after 2 hours as the cabin was completely burned out while the tanks were incandescent (Fig. 1c). However, after being calm for over half an hour, the fire suddenly intensified at 3:21 p.m., resulting in flames that enveloped the whole truck (Fig. 1d). Eventually, the flames propagated towards the rear of the truck and finally culminated in an explosion at 3:26 p.m., 2 hours and 26 minutes after the fire was discovered (Fig. 1e). Immediately after the explosion, glowing droplets filled the sky (Fig. 1f).

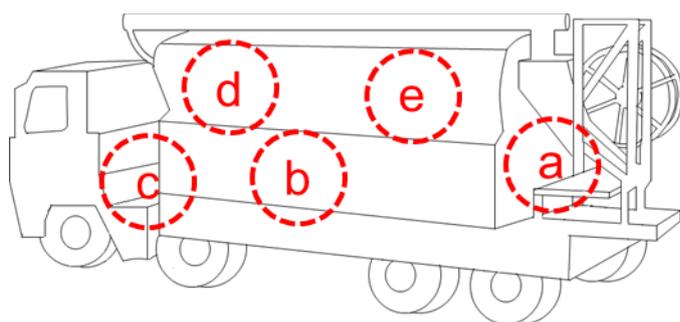
A MEMU-vehicle carries a number of precursors used for the on-site production of AN-based explosives and consists of several tanks, bulk containers, processing equipment and pumps. At the time of arrival, the MEMU in Drevja carried ANPP, ANE, aqueous sodium nitrate (SN) solution and aqueous acetic acid (AA). The MEMU was also equipped with a diesel tank for explosives manufacturing purposes in addition to the vehicle's fuel- and hydraulic oil tank (Fig. 2). The ANPP tank was situated directly behind the cabin while the ANE tank was placed at the rear of the truck. These two tanks, which were the largest tanks on the vehicle, were separated by an 800 L water tank.

Fig. 2: Schematic drawing of the approximate position of cargo tanks containing a) production diesel; b) gassing agents; c) fuel tank; d) ANPP and e) ANE.

All tanks, except the vehicle fuel- and hydraulic oil tank, were constructed in aluminum. It has been estimated that 950 kg of the emulsion explosive had been produced at the time of evacuation (Table 1) [1].

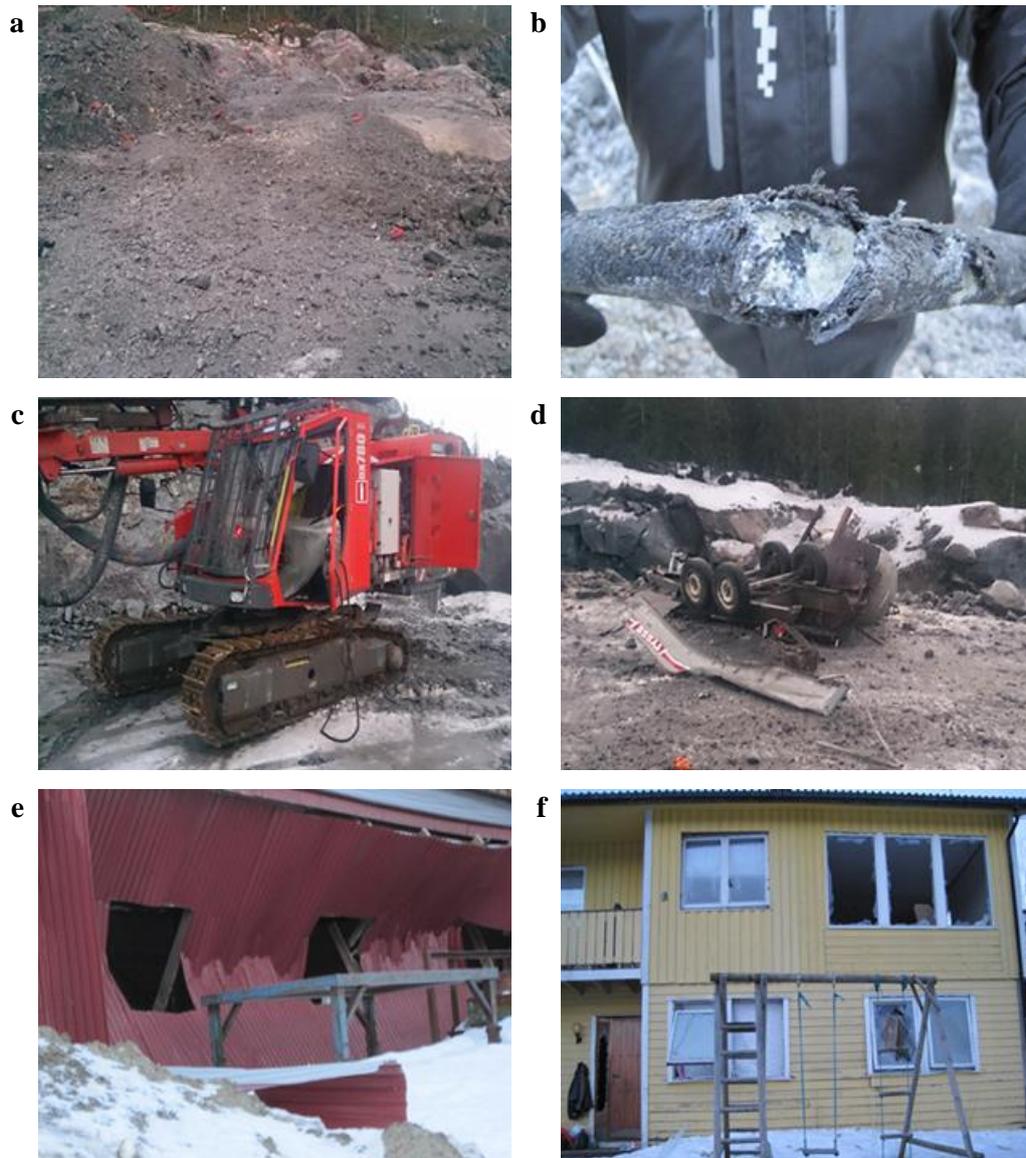
As the accident area was cordoned off until the next day, the post-blast inspections started in the afternoon of December 18, 2013. The most surprising observation was the almost complete lack of fragments at the explosion site (Fig. 3a). The loading hose was, however, found more or less intact approximately 40 meters from the site, still containing the explosives product mixture (Fig. 3b). The residues were later analyzed by the respective supplier and found to comply with all governmental regulations [1].

All cartridge explosives, initiators and boreholes (located 8-10 meters from the vehicle) were found intact and only a few of the borehole plugs were affected by the high temperatures. In contrast to this, apparatus and equipment close to the site were clearly affected by the shock wave as indicated by damages such as shattered windows and bended steel parts (Fig. 3c-d). Residences up to 350 m away from the site were also greatly affected (Fig. 3e-f). In addition to this, a residential house had been ignited by fragments and burned to the ground. In total, 20 buildings were affected and 22 people were evacuated. Fortunately, there were no human injuries or fatalities.

No obvious impact crater was identified after the event. This was a bit unexpected seeing that an explosive charge usually will create an explosion crater if set off on a surface. Its dimensions will depend on the size, shape and type of charge, as well as the charge's distance from the surface and the properties of the rock surface. According to geological surveys of the quarry conducted prior to the accident, the rock surface at the explosion site consisted mainly of mica schist [1]. Mica schist, a crystalline metamorphic rock, has a foliated or plated structure with a tendency to split into layers. The breaking rate of mica schist during blasting is known to be very low due to its high ductility, a property which is defined as a rock's ability to deform under high stress without being fractured. Thus, even during regular blasting operations, mica schist is a problematic type of rock concerning its resistance to destruction [2]. When taking into account the low brisance of AN-based explosives and

the non-ideal blasting conditions, the lack of an explosion crater under these circumstances is probably not anomalous.

Fig. 3: Pictures of damages at the accident site: a) Point zero one day after the explosion. No explosion crater can be seen. b) The only remaining part of the truck at point zero. The hose was still intact, containing the explosives product. c) An excavator at the quarry with shattered windows. d) A trailer standing few meters from the explosion shattered from the shock wave. e) Structural damages to a pig house 226 m from point zero. f) Shattered windows on a residential home, 210 m from point zero.

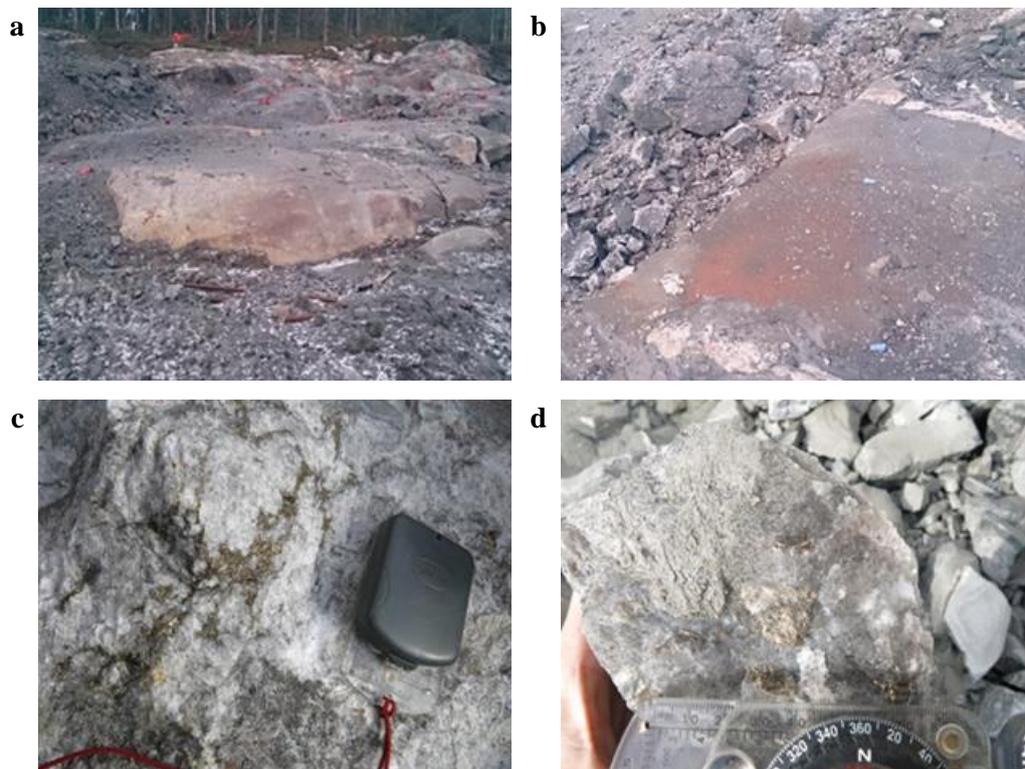
Inspections of the rock surfaces where the MEMU-truck was located during the fire revealed newly appeared rust colored stains (Fig. 4a-b). As the stains were not subjected to chemical analysis, it is impossible to determine their direct cause, nevertheless, the geological investigations suggested that this could only have been caused by the energetic event as the stains were embedded in the rock material. A plausible source to the stains could be iron-containing minerals. In fact, small amounts of pyrite (FeS_2) had been identified sporadically in the rock surfaces in the quarry (Fig. 4c-d), a mineral that is not uncommon to find in the metamorphic mica schist. When subjected to high temperatures and/or oxidizing agents, pyrite decomposes to yield iron salts such as rust (Fe_2O_3) [3]. Such an agent

could simply be atmospheric oxygen, but it is also well-known that pyrite reacts with ammonium nitrate also to produce Fe_2O_3 [4, 5]. Lacking empirical evidence, any discussions on linking the cause of the stains and the initiation of the explosion will be dubious and will thus not be implied or debated here. However, these observations at least underline the extreme temperatures and conditions present during the event and may also suggest that material from the tanks can have leaked out and reacted with the rock surface.

Fig. 4: a-b) The red-stained rock surface observed after the incident; c-d) Rock specimens at the quarry in Drevja showing pyrite ores.

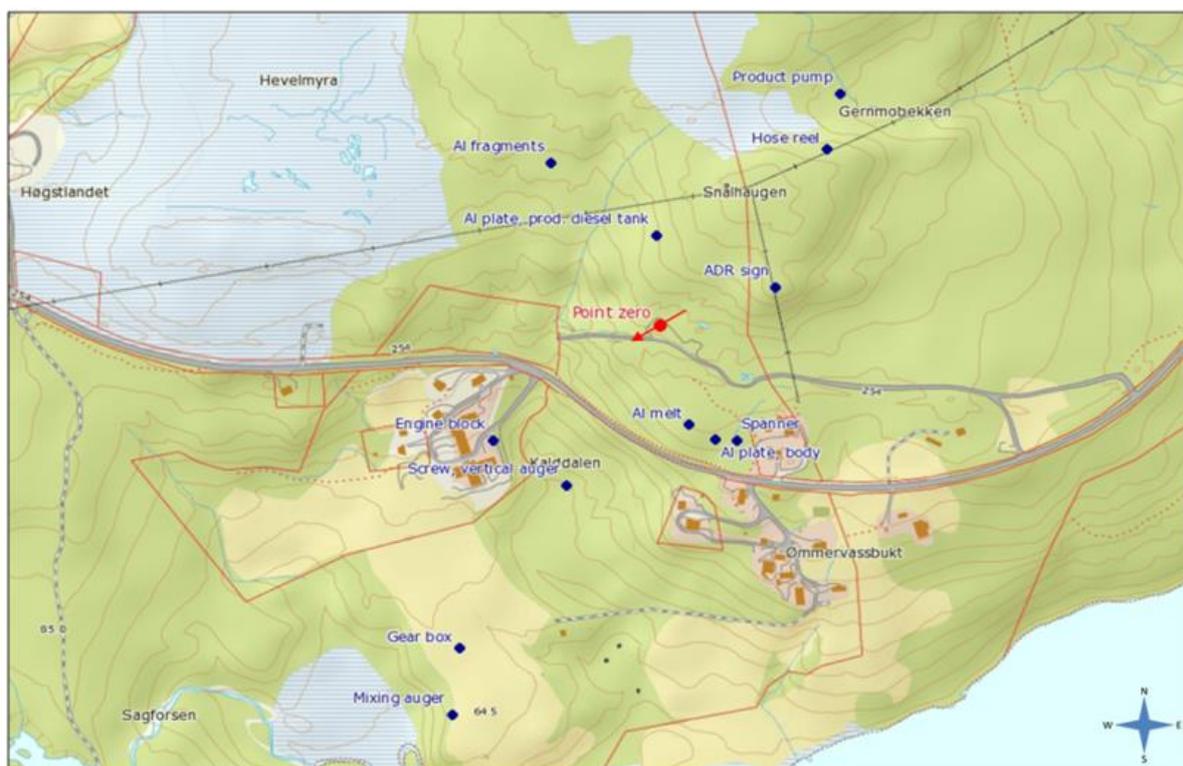
In June 2014, a thorough search for fragments was performed at the accident site in Drevja. More than 340 fragments were collected and registered, including the engine block, gear box, parts of the pump and augers and a large amount of aluminum and steel parts from the chassis and tanks (Fig. 5). The collected amount totaled of approximately 1/3 of the original weight of the truck's non-combustible material, 1/3 of these consisted of aluminum while the remaining 2/3 were made of steel.

Fig. 5: Overview map of selected vital fragments. UTM coordinates for the zero point are 33W E425637 N7319534, 110 m above sea level. The arrow represents the original position of the MEMU truck with its front pointing in the arrows' direction.

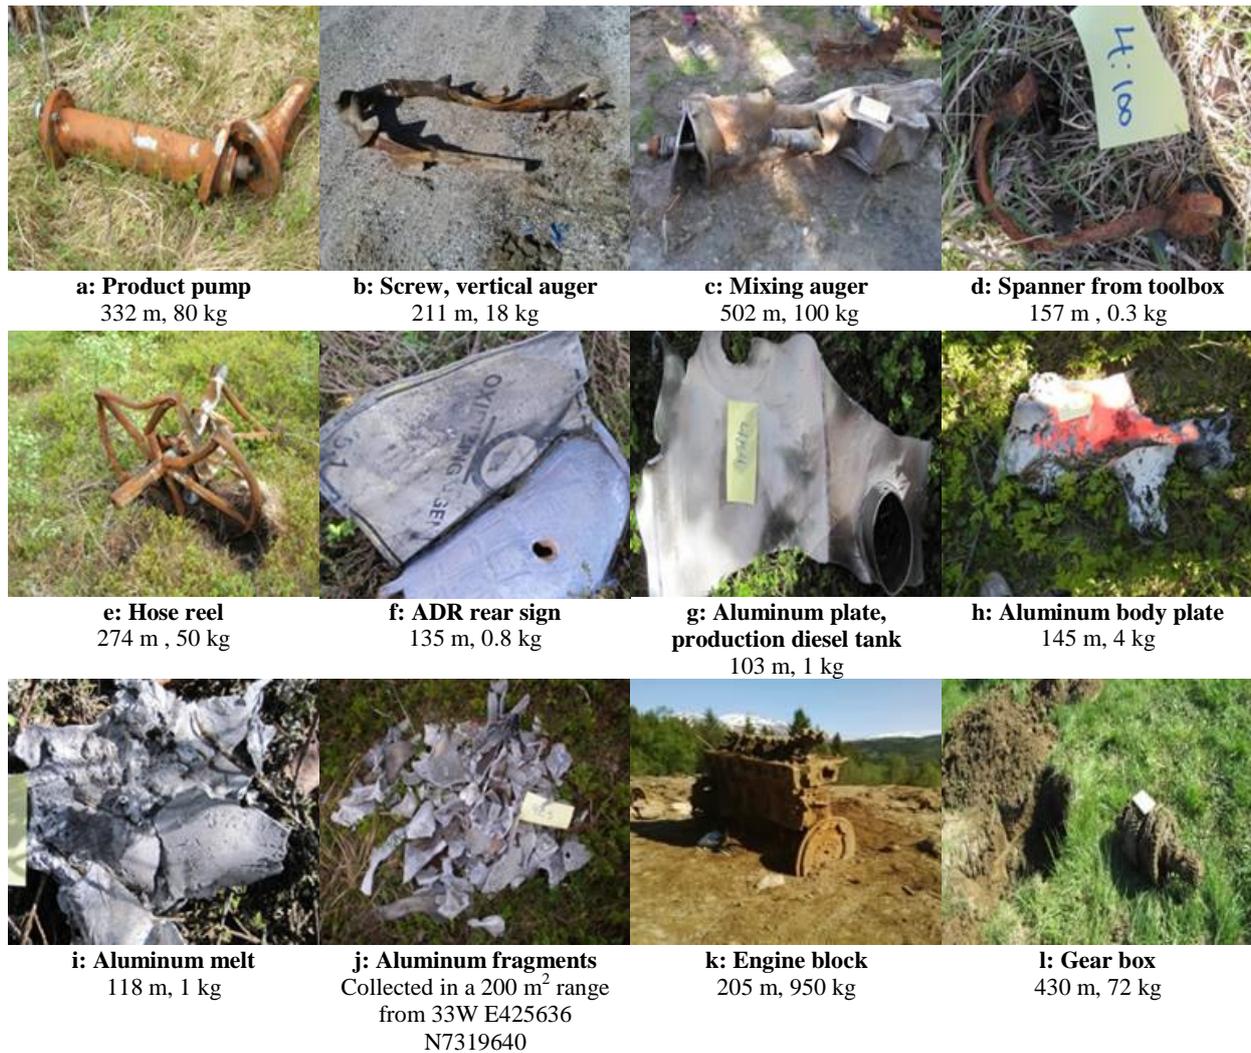
Even though a large amount of fragments were collected, some of them were of particular importance. The pump and all mixing augers from the manufactory unit were retrieved, however; even though these parts must have contained the final explosive product when the fire started, they did not show any signs of internal explosions (Fig. 6a-c). Indeed, the retrieved parts of the pump did contain a large amount of intact product residues, making it highly unlikely that these parts were involved in any initiation of the explosion.

The recovery of bended and twisted steel parts and tools indicated fire temperatures close to the melting point of steel (Fig. 6d). Larger steel fragments were also visibly affected by the high temperatures (Fig. 6b and 6e). As the fire started in the front of the vehicle and propagated backwards, the front ANPP tank must have been exposed to more heat over a longer timespan than the rear ANE tank. This notion is supported by the fact that the parts originating from the rear of the truck looked less affected by the heat compared to the parts from the front (Fig. 6f-h). Several melted lumps of aluminum were found in the area (Fig. 6i), which implies that at least one of the cargo tanks must have melted due to the elevated temperatures. This is a quite interesting observation as the use of aluminum transportation tanks for these types of AN-based compositions actually is a general approach in the Nordic countries [1]. It is regarded as a safety measure which prevents confinement by the virtue of aluminum's ability to weaken, melt and rupture at far lower temperatures than steel.

Fig. 6: Pictures of selected vital fragments with their respective weights and travelling distance (their respective retrieval points can be found in Fig. 5). Weights > 5 kg are estimates based on weights of original parts.

A large amount of small aluminum fragments were also collected (Fig. 6j). In average, the aluminum fragments weighed less than 50 grams and were smaller than 10 cm². Most of them were found up to 200 meters from the explosion site, mainly in the direction behind and on the lateral sides of the vehicle's original position, while very few were found in the front. When reviewing the appropriate Gurney equations in this case, fragments of these sizes could only have travelled such a distance if the metal was in direct contact with the explosive material during detonation. Furthermore, the lack of aluminum pieces in the front suggests that the cabin must have blocked the fragments moving in this direction, thus indicating that the explosion must have taken place quite close to the cabin. If the detonation took place farther behind, more aluminum fragments should have travelled in a forward direction. The size, shape and scattering of aluminum fragments imply that an explosion took place in at least one of the tanks. If the rear tank did not detonate, larger parts of this would probably have been found. The fact that no large fragments of any tank were retrieved, strongly suggests that a detonation took place in both tanks.

The engine block was by far the largest fragment collected, with an approximate weight of 950 kg (Fig. 6k). It was retrieved 200 meters from and 32 meters below the zero point (Fig. 5). Simple, ballistic calculations indicate an initial velocity of at least 40 m/s. In order to find whether this distance and velocity complies with the amount and location of the explosive, the load on the engine block was simulated.

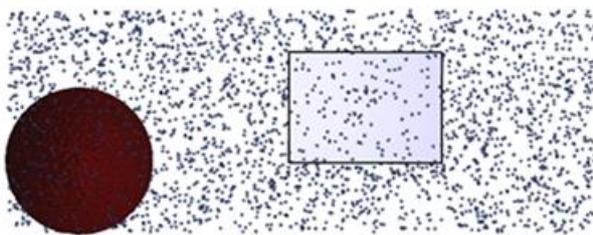
In our case, the engine is represented as a rigid block with the appropriate dimensions and positioning and a weight of 900 kg (Fig. 7). The ground is represented as a solid wall. Thus, the interaction between the air and the explosive, and that between the engine and the gases, as well as the reflection from the ground, should be well represented. It is the transfer of impulse from the detonation products to the engine that propels the engine. The explosive charge was modeled as TNT since the properties of AN-based explosives were not available in the program settings. However, this will not have any great influence on the final results. The explosive load was varied between 300-900 kg and its shape was varied between a sphere, hemisphere and a cone. Furthermore, the distance between the ground level and the engine block was fixed at 0.5 m while the horizontal distance between the engine block and the explosive was varied (Table 2). Since there are no indications on where the detonation was initiated, it is presumed that the detonation takes place instantly in the whole explosive mass.

Fig. 7: General configuration used for simulations showing the explosive charge to the left (sphere) and the engine block (rectangle, 1.1 x 0.8 x 0.5 m) positioned slightly to the right of the center. 200,000 particles were in general used as a standard. The vertical position between the engine block and the ground was fixed at 0.5 m while the horizontal distance block-to-explosive distance was varied. The explosive charge was modeled as TNT.

Some general conclusions from the resulting calculations can be deduced: If the explosive charge is positioned 0.5-1.0 m from the engine, it is crucial that the charge is of an explosive yield greater than 900 kg TNT. This is necessary to provide the appropriate initial velocity. However, if the explosive charge is positioned less than 0.5 m from the engine, an explosive equivalent of 600 kg TNT will be sufficient. In addition, the calculations implied that the charge must be close to and partly below the engine block to give an elevated trajectory. Several other configurations could probably provide similar results but, it is highly likely that these would be of very similar character with only small variations in angle, velocity and positioning of the explosive charge.

According to the simulations, the engine block could only have reached its site of retrieval in two ways; either by an almost horizontal ejection angle caused by a detonation above ground, indicating a scenario whereby the block could have hit the ground downhill and then ricocheted further, or by an elevated trajectory that would bring it directly to its site of rest. The latter, would imply that a substantial part of the detonation took place partially below the engine, i.e. at the ground. In contrast, the first possibility implies that the explosion started inside the front tank. This can, however, be ruled out based on the retrieval of the gearbox (Fig. 6l). This item was found in almost the same direction as the engine, but 430 m away from the zero point. As the gearbox is smaller and its shape enables it to catch more impulse per weight compared to the engine, it would be expected that its ejection velocity is higher. Since the gearbox could not have reached its retrieval site other than by an elevated trajectory, it strongly indicates that the load originated from a point below the engine and the gearbox. As a consequence, the detonation must have initiated in a leaked-out content, most likely from a tank in close proximity to the engine.
